Coal Tar Migration in a Multiaquifer Well at the Reilly Site – The Story of Well W23

Introduction and Background

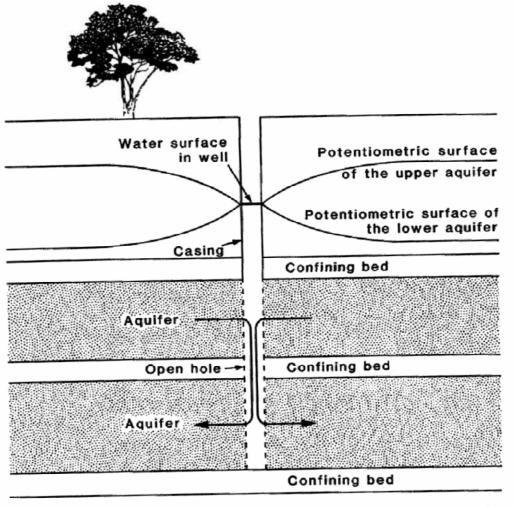
Figure 14. Schematic hydrologic section showing a well connecting two confined aquifers, flow through the well bore, and the effects of this flow on the potentiometric surfaces of the two aquifers
