Challenges of Protecting and Restoring a Groundwater - Dependent Prairie Stream: Iron Springs Creek, Southeastern North Dakota

Phil Gerla

*Midwest Groundwater Conference 2012
Groundwater Opportunities and Conflicts in the 21st Century:
Economy to Ecology*

Purpose of the presentation – Case study that demonstrates how drainage mismanagement irreversibly damaged Iron Springs Creek

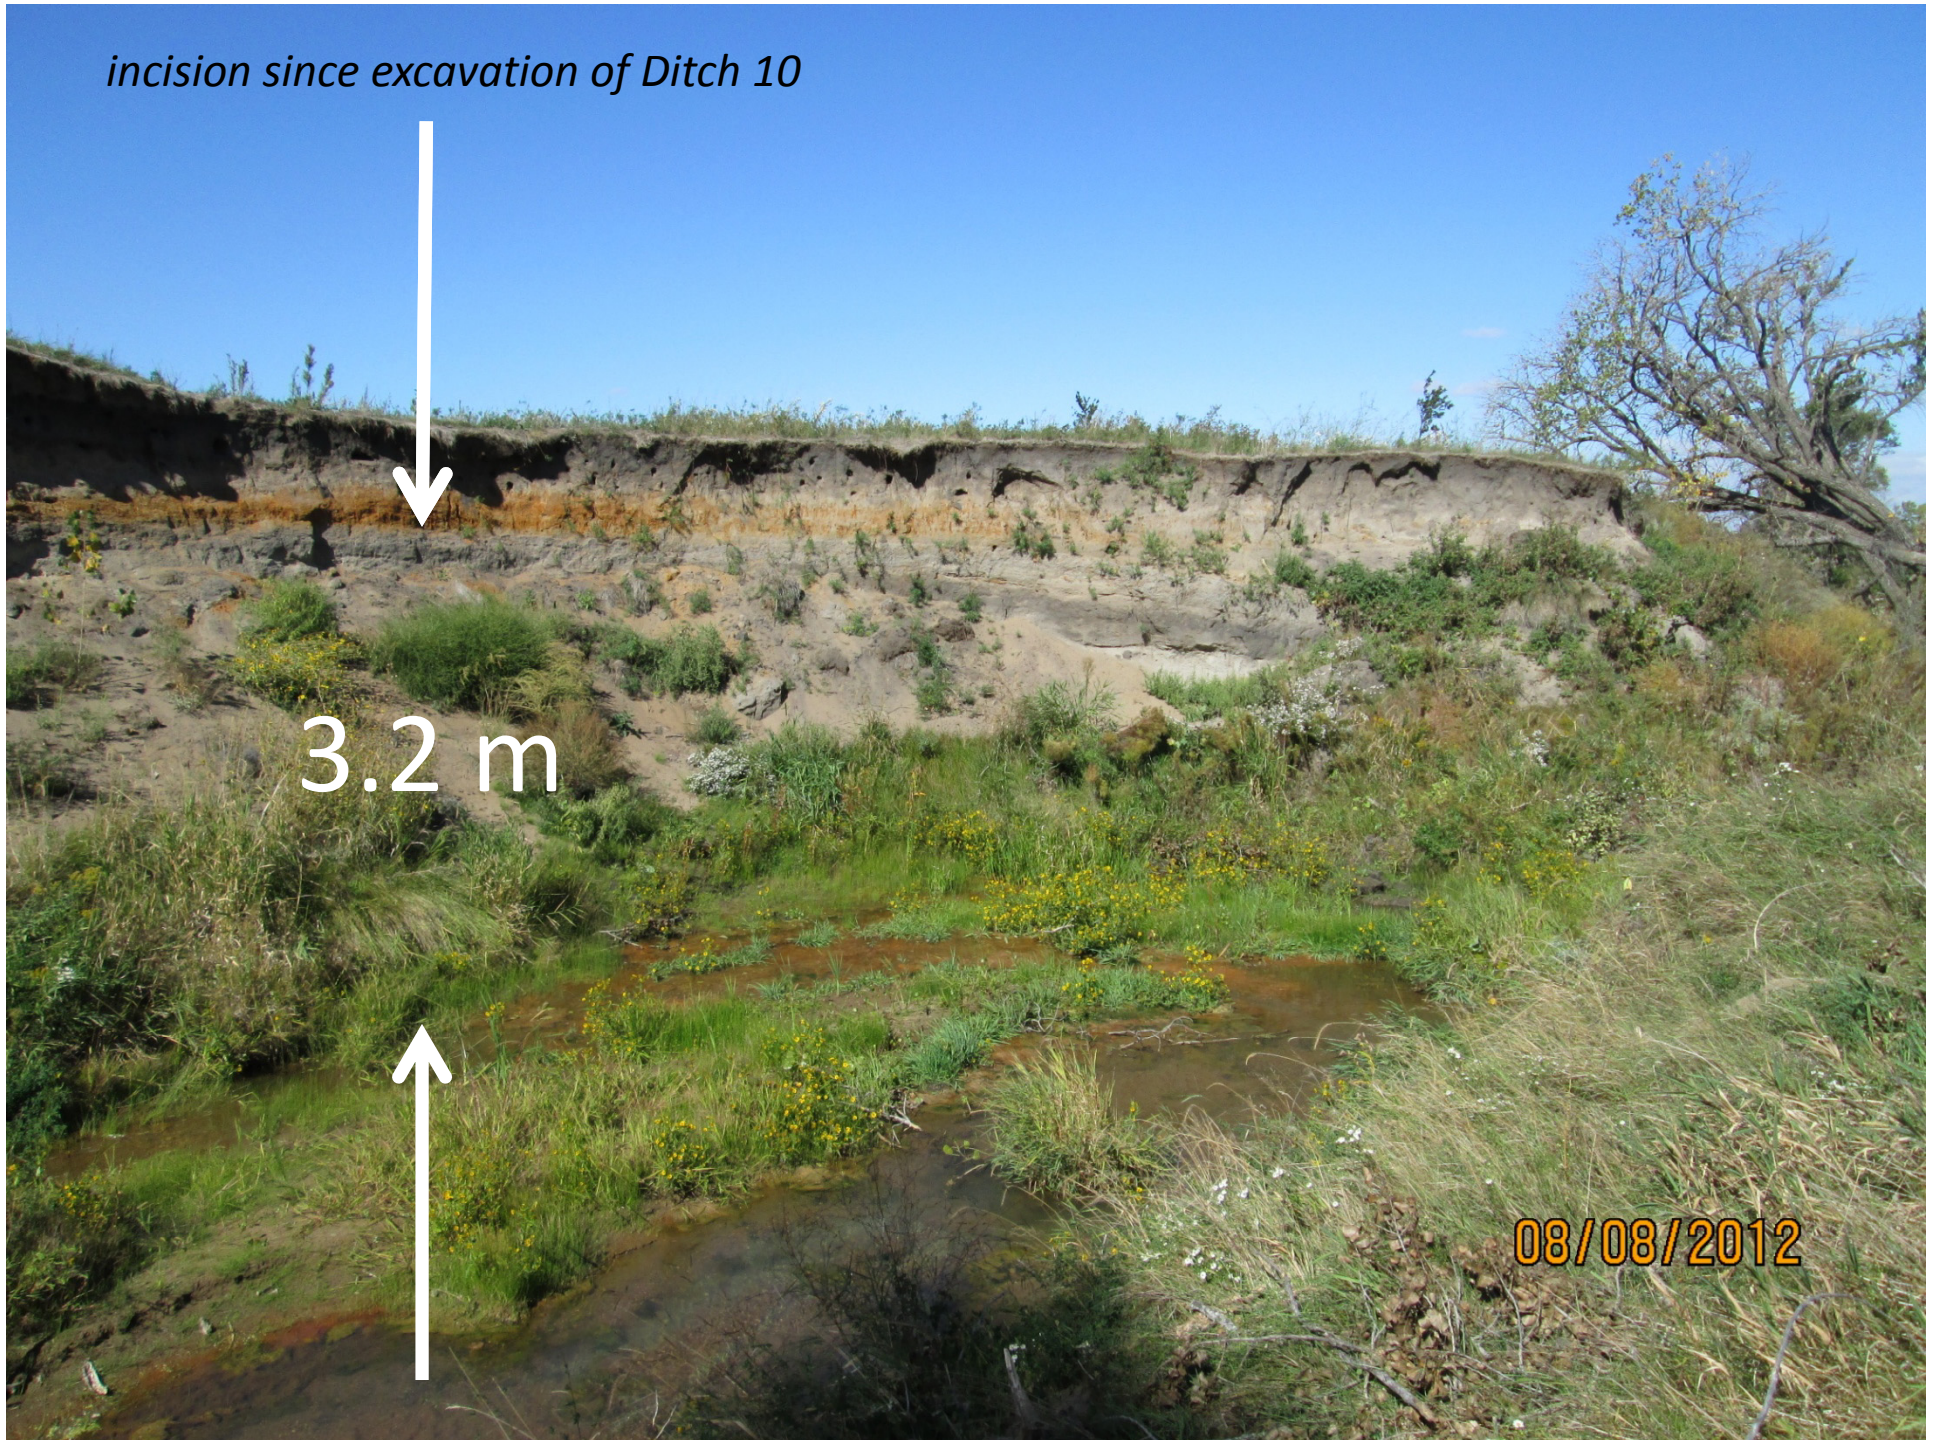
incision since excavation of Ditch 10

3.2 m

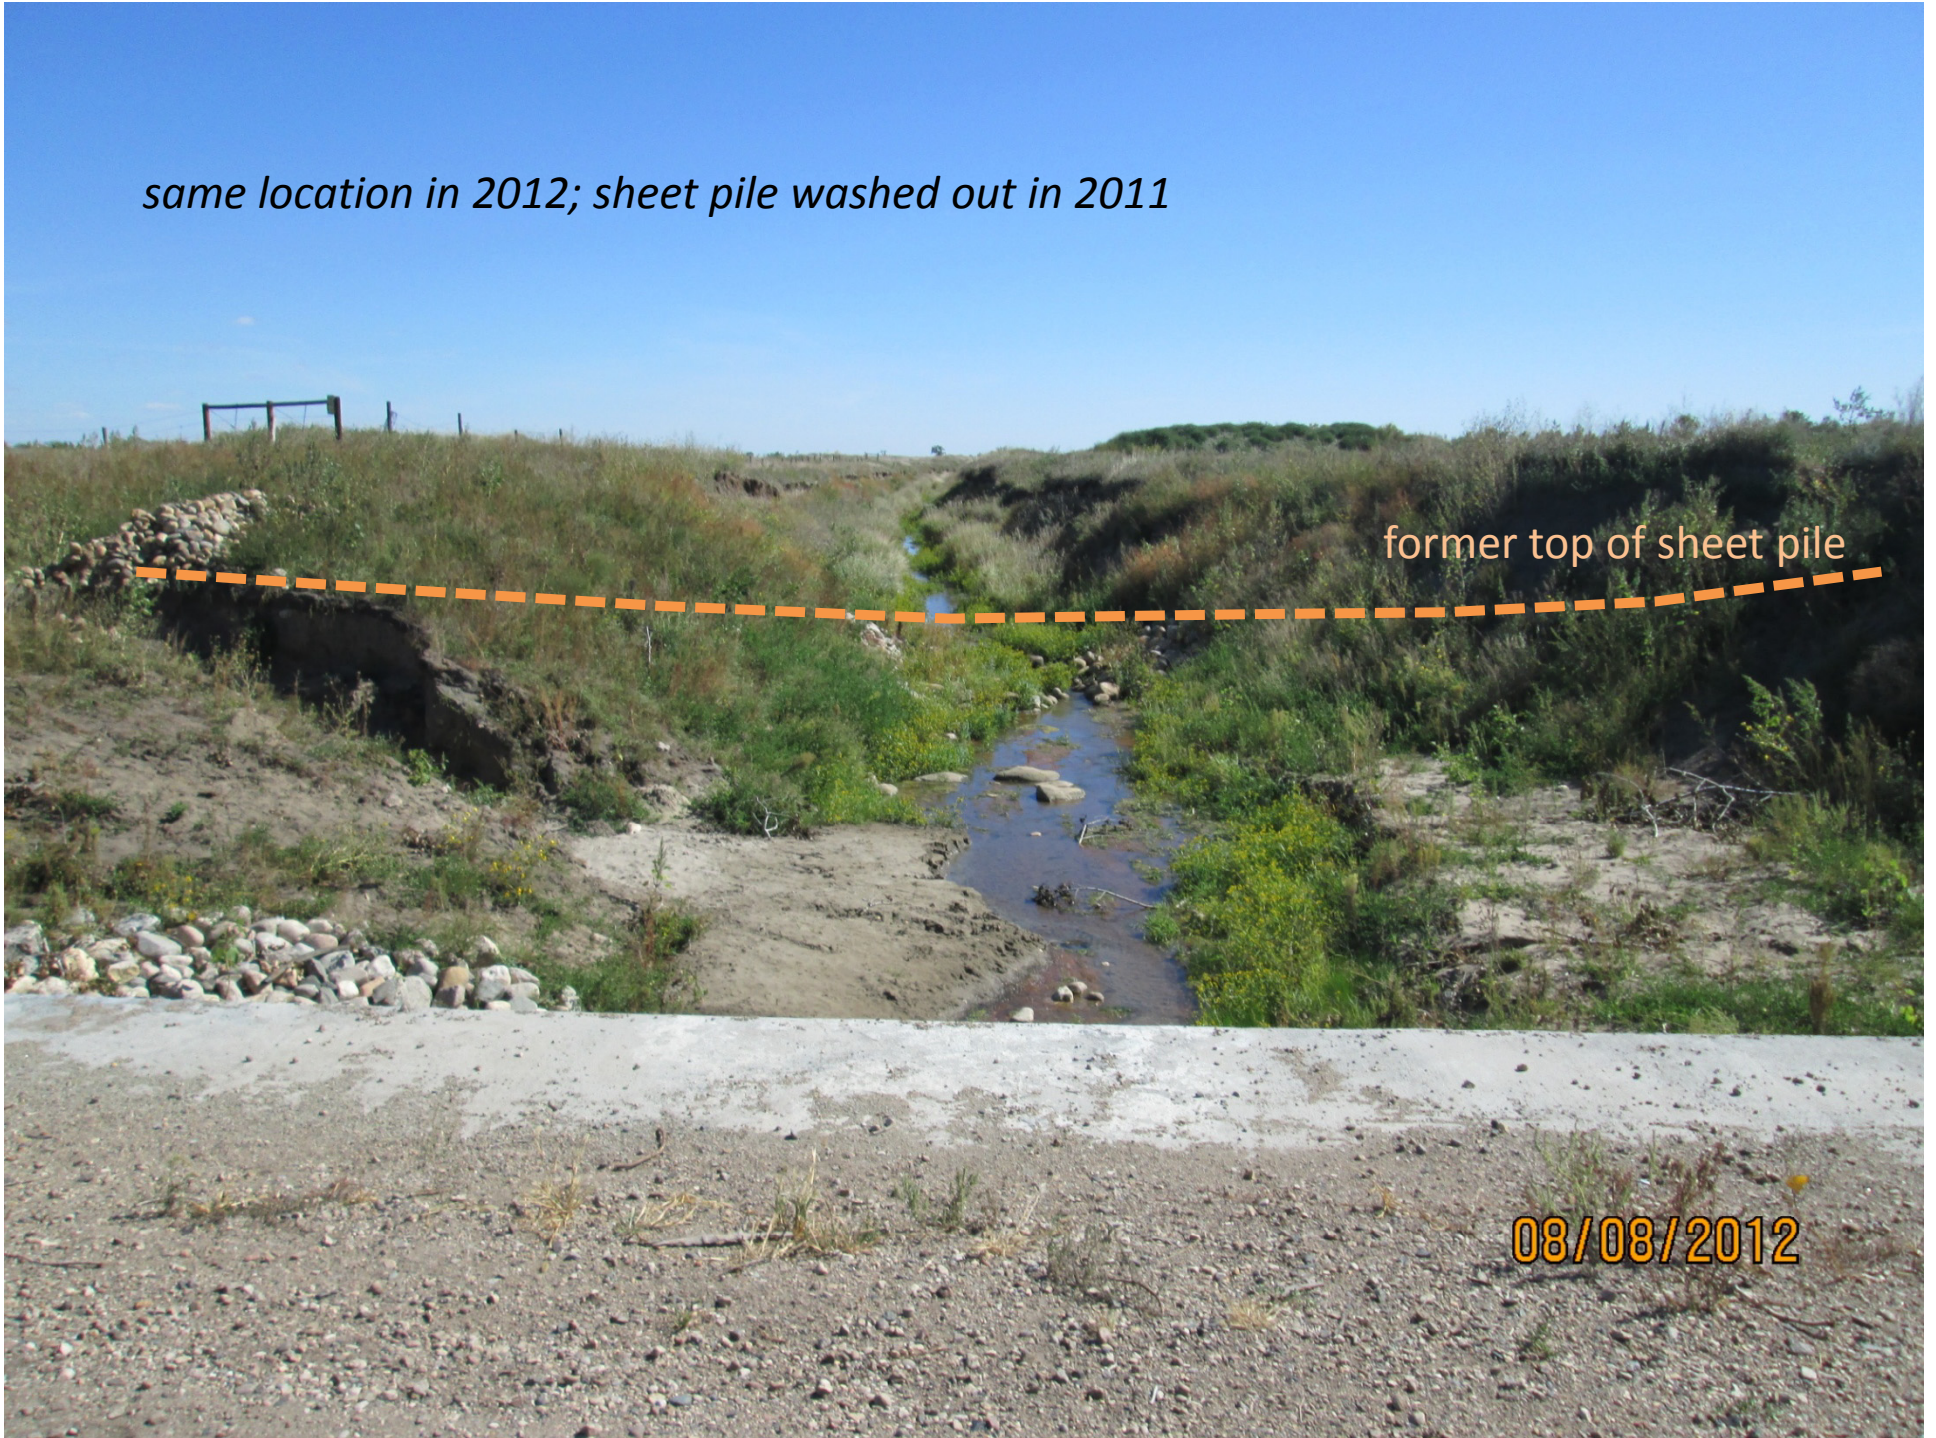
same location in 2012; sheet pile washed out in 2011

former top of sheet pile

What caused weir failure and resulting rapid incision in 2011? --- historically high water

What caused weir failure and resulting rapid incision in 2011? --- a much larger watershed

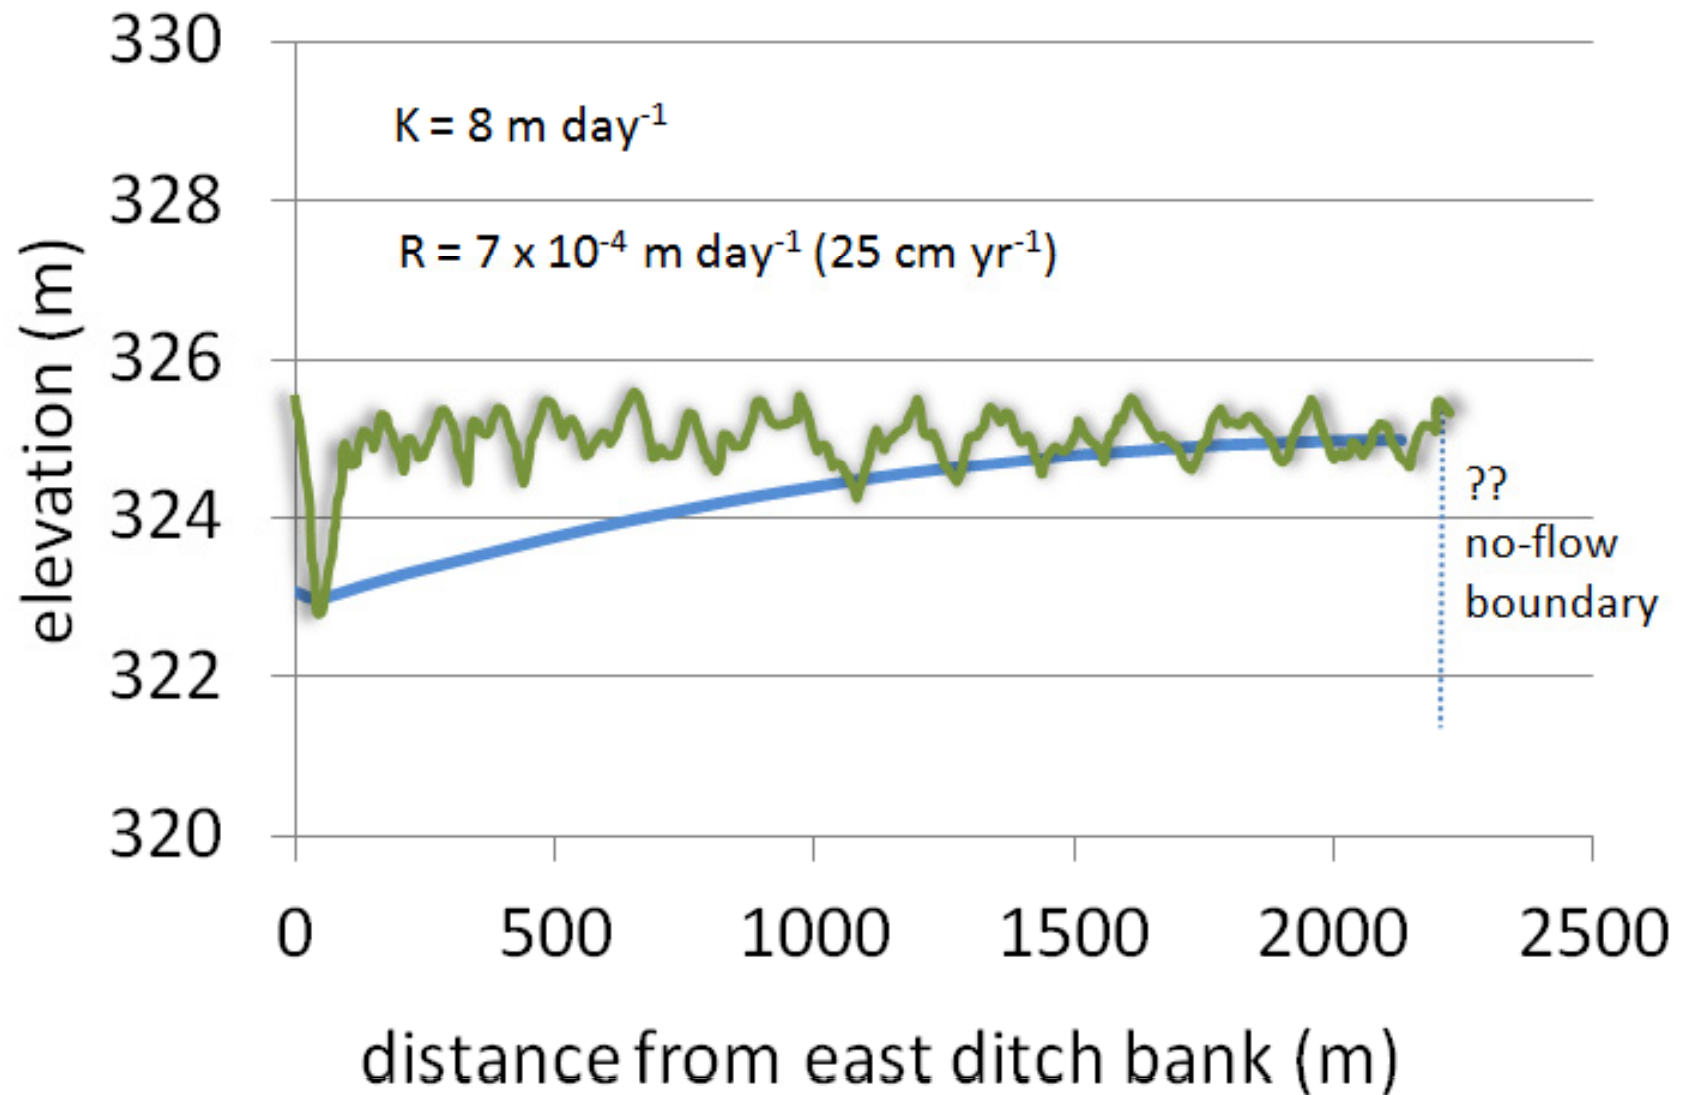
loss of wetlands – basic steady-state model of drainage

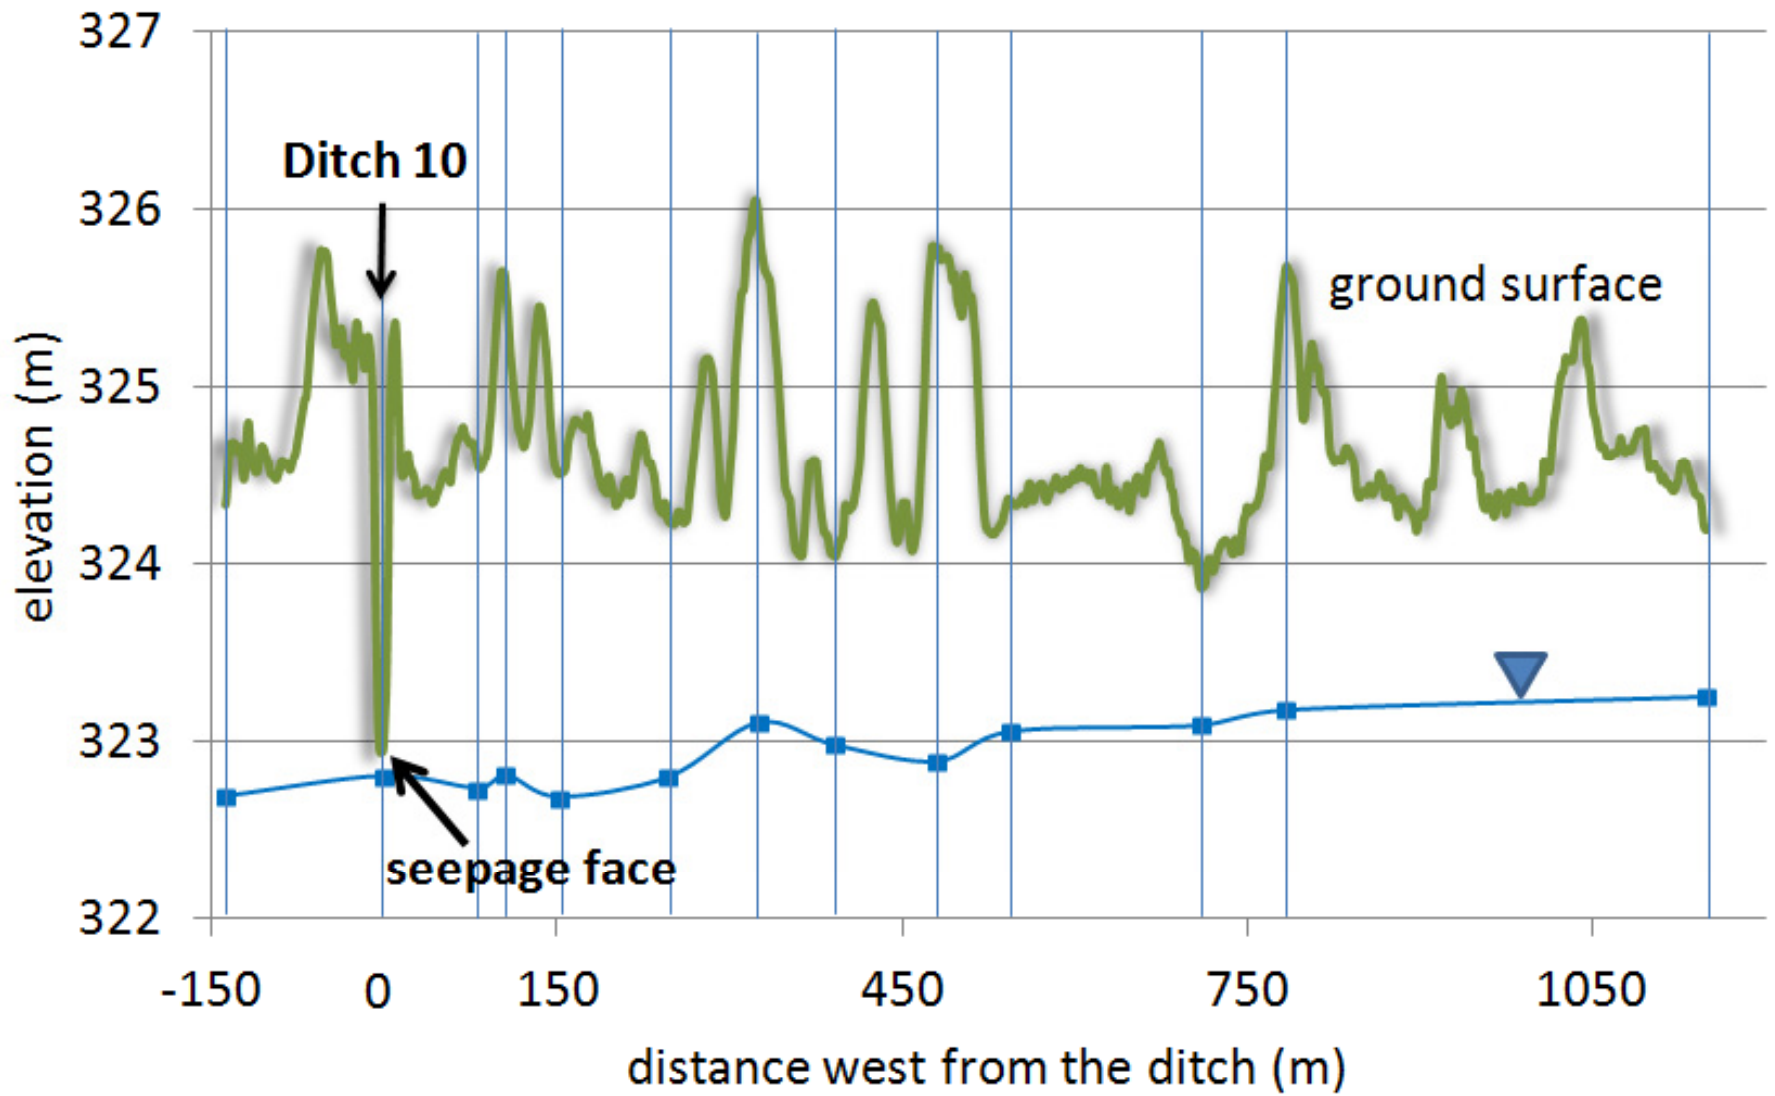
loss of wetlands – observed drainage
