# Hydraulic Impacts of Quarries and Gravel Pits

J.A. Green, J.A. Pavlish, R.G. Merritt, and J.H. Leete  
Minnesota Department of Natural Resources,  
Division of Waters

Legislative Commission on Minnesota Resources

2005

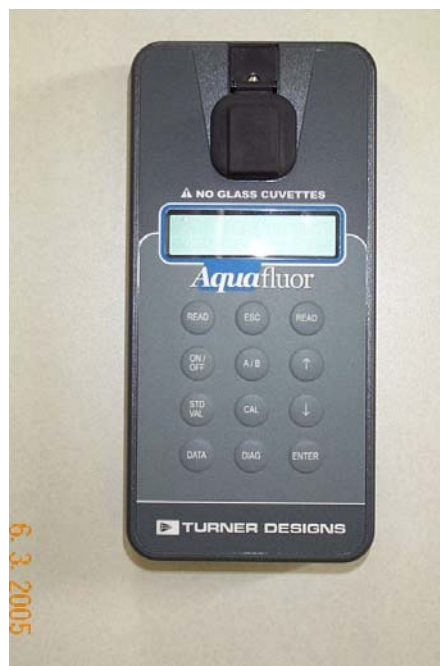
Figure 8.9. Handheld fluorometer.
