Impact of the 2011 **Missouri River Flooding** on Groundwater Levels in Bismarck and Mandan, North Dakota

North Dakota State Water Commission Royce Cline Steve Pusc

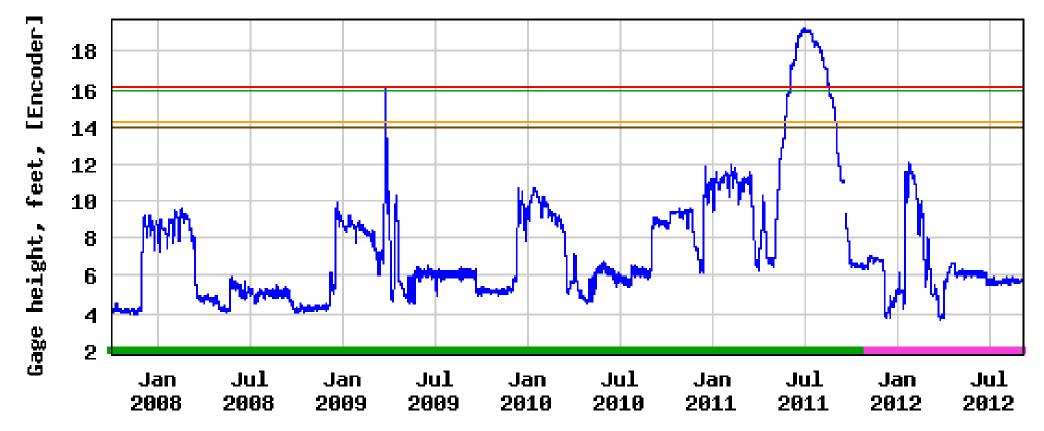
USGS 06342500 MISSOURI RIVER AT BISMARCK, ND

Flood stage major 18.0' moderate 16.0'

- Gage height
- Period of approved data
- ---- Period of provisional data
  - Peak gage height in 2009
- - Peak gage height in 1975
  - Peak gage height in 1997

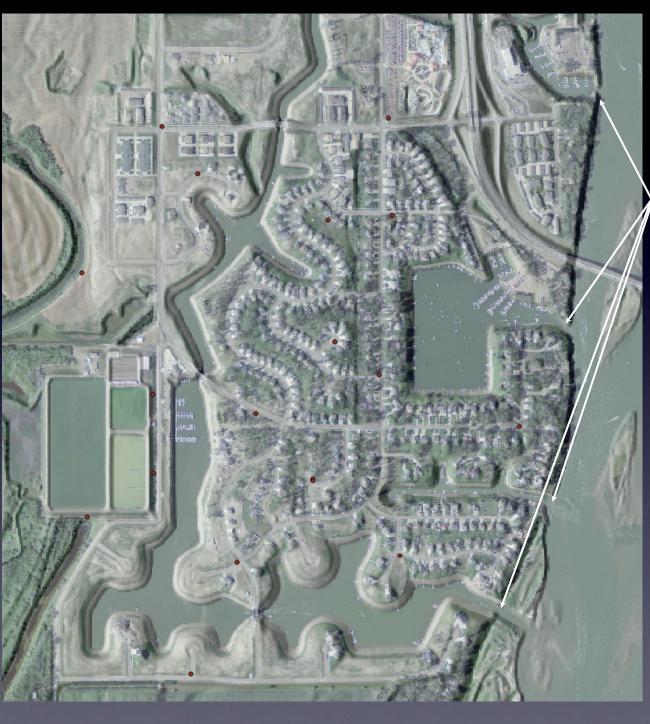
#### June 16, 2011 River stage 18.34 ft.

Dikes were built across the mouths of the bays and then pumped to control the water levels within the development.

Head differential between the bays and the river was not allowed to exceed 3 feet to prevent sand boils from developing in the bottom of the bays.
