# The Combined Application of LiDAR, Aerial Photography and Pictometric Tools for Sinkhole Delineation

Scott C. Alexander, Mina Rahimi Kazerooni, Erik Larson, Cody Bomberger, Brittany Greenwaldt, and E. Calvin Alexander, Jr.

Dept. of Earth Sciences, University of Minnesota, 310 Pillsbury Dr SE, Minneapolis, MN 55455

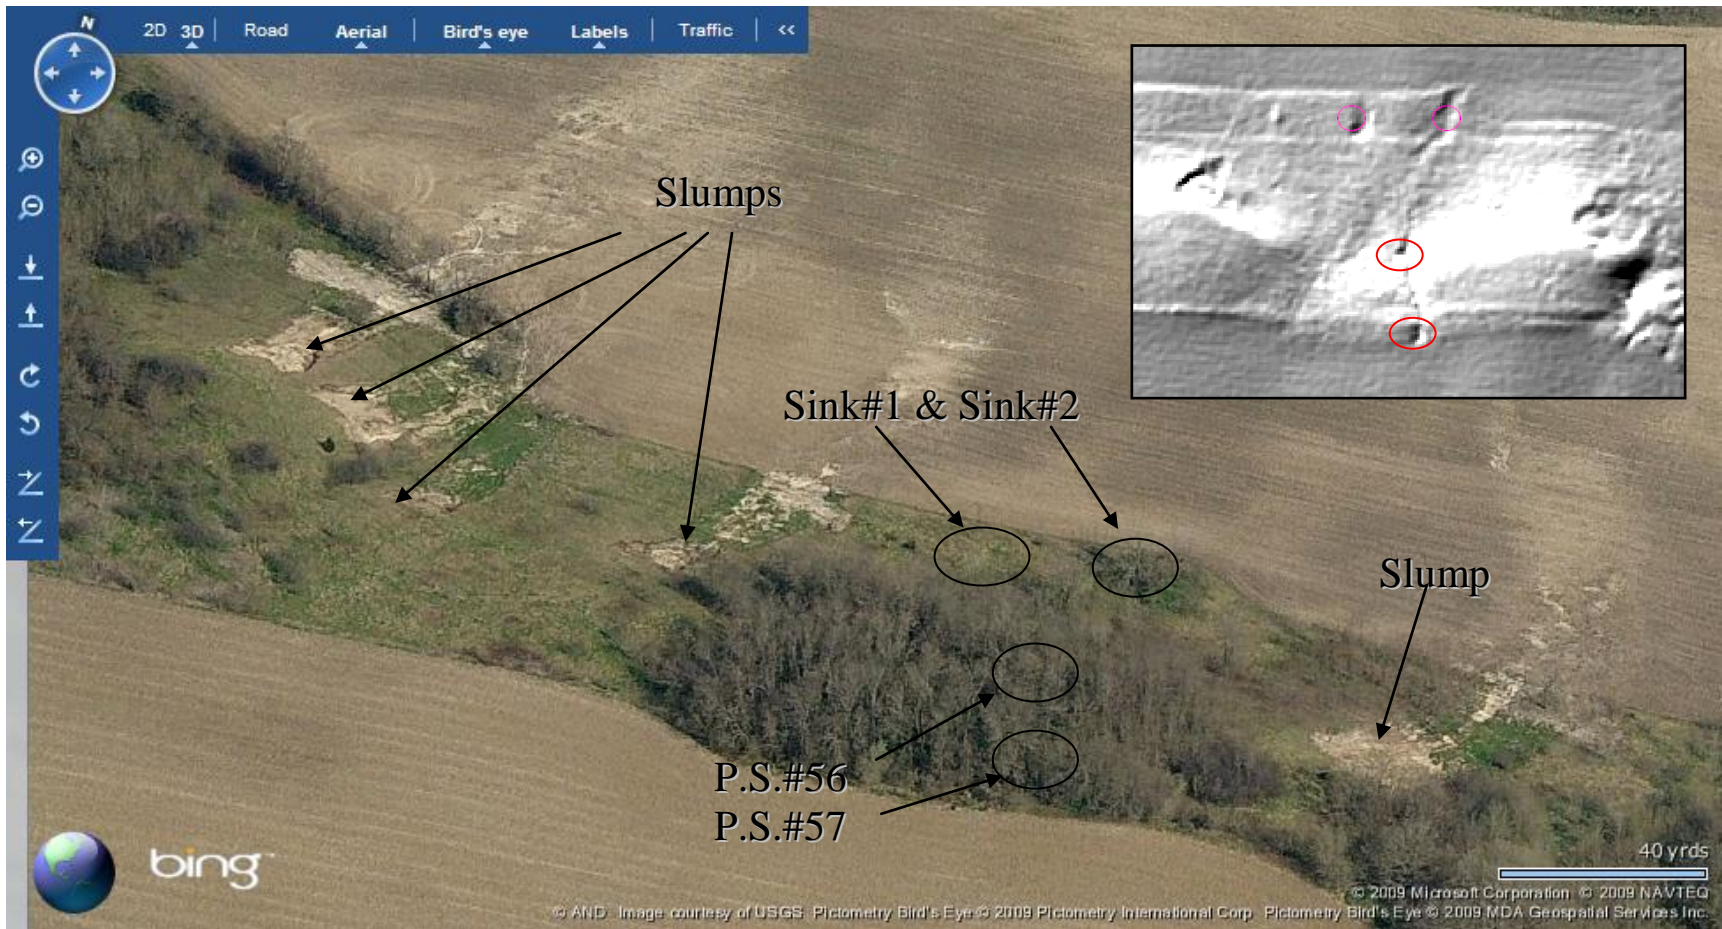
Lidar and Pictometric view to the North. Circled areas to be field checked. Possible sinks or may be related to older slumps.

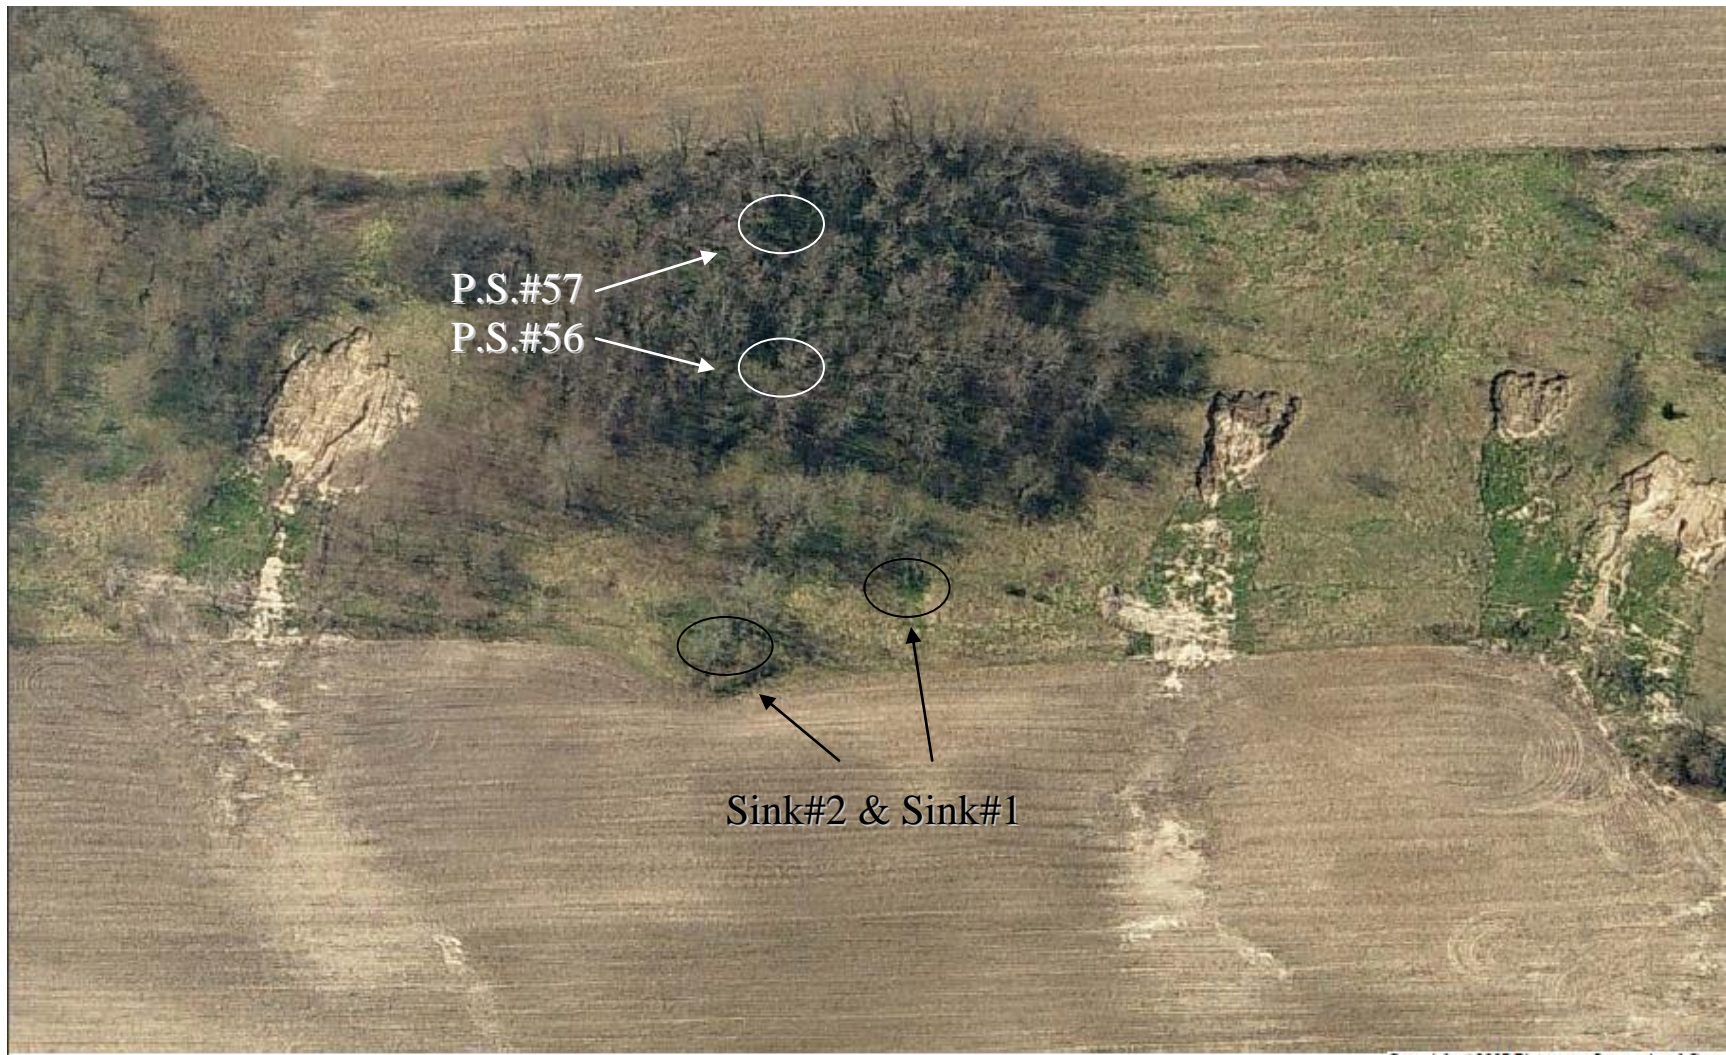
Based on this Southward Pictometric view Sink#1 and #2 are sinkholes. Possible sinks #56 and #57 need to be field checked.

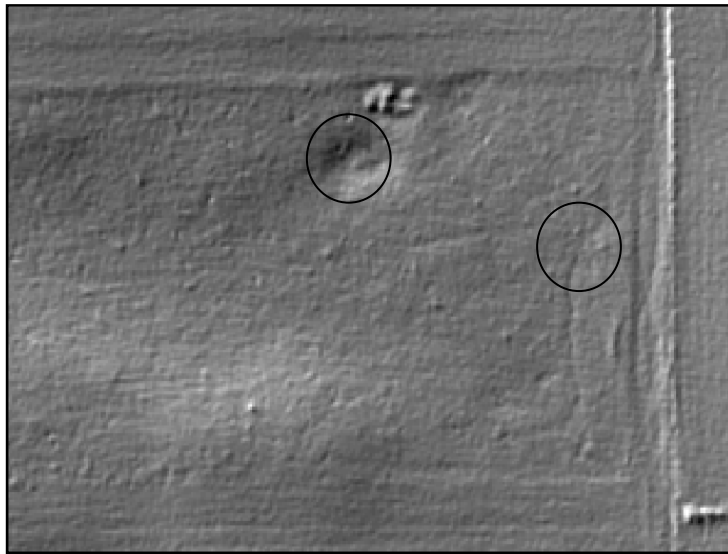
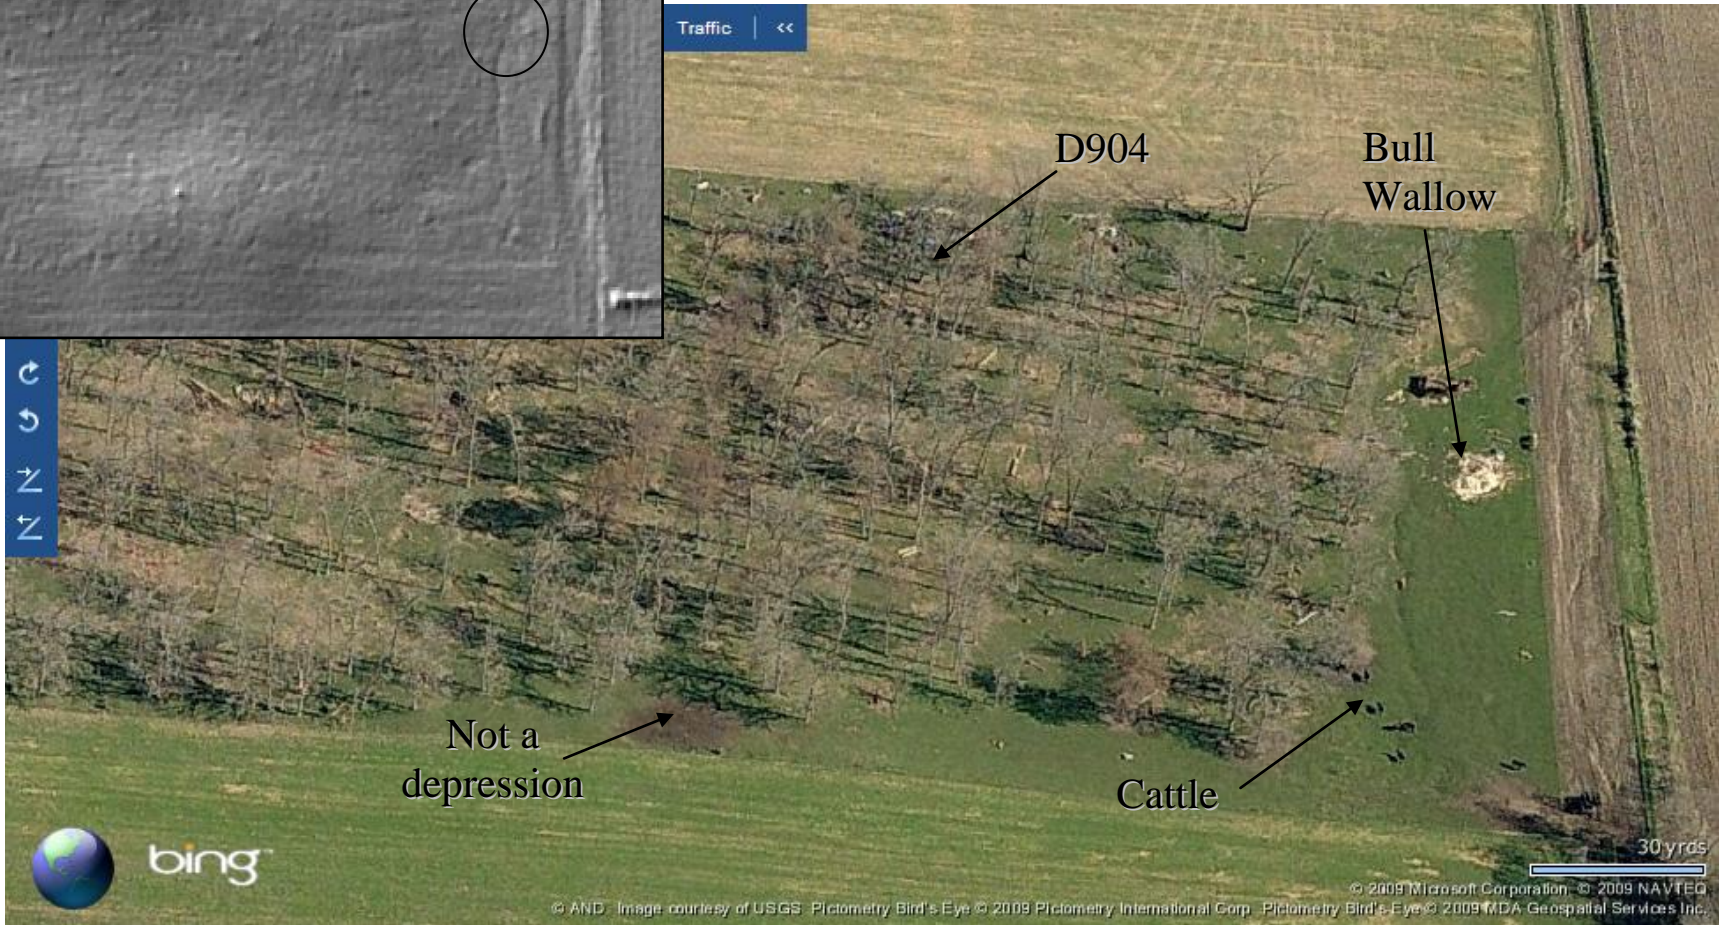
Example of a sinkhole (D904) and a bull wallow.

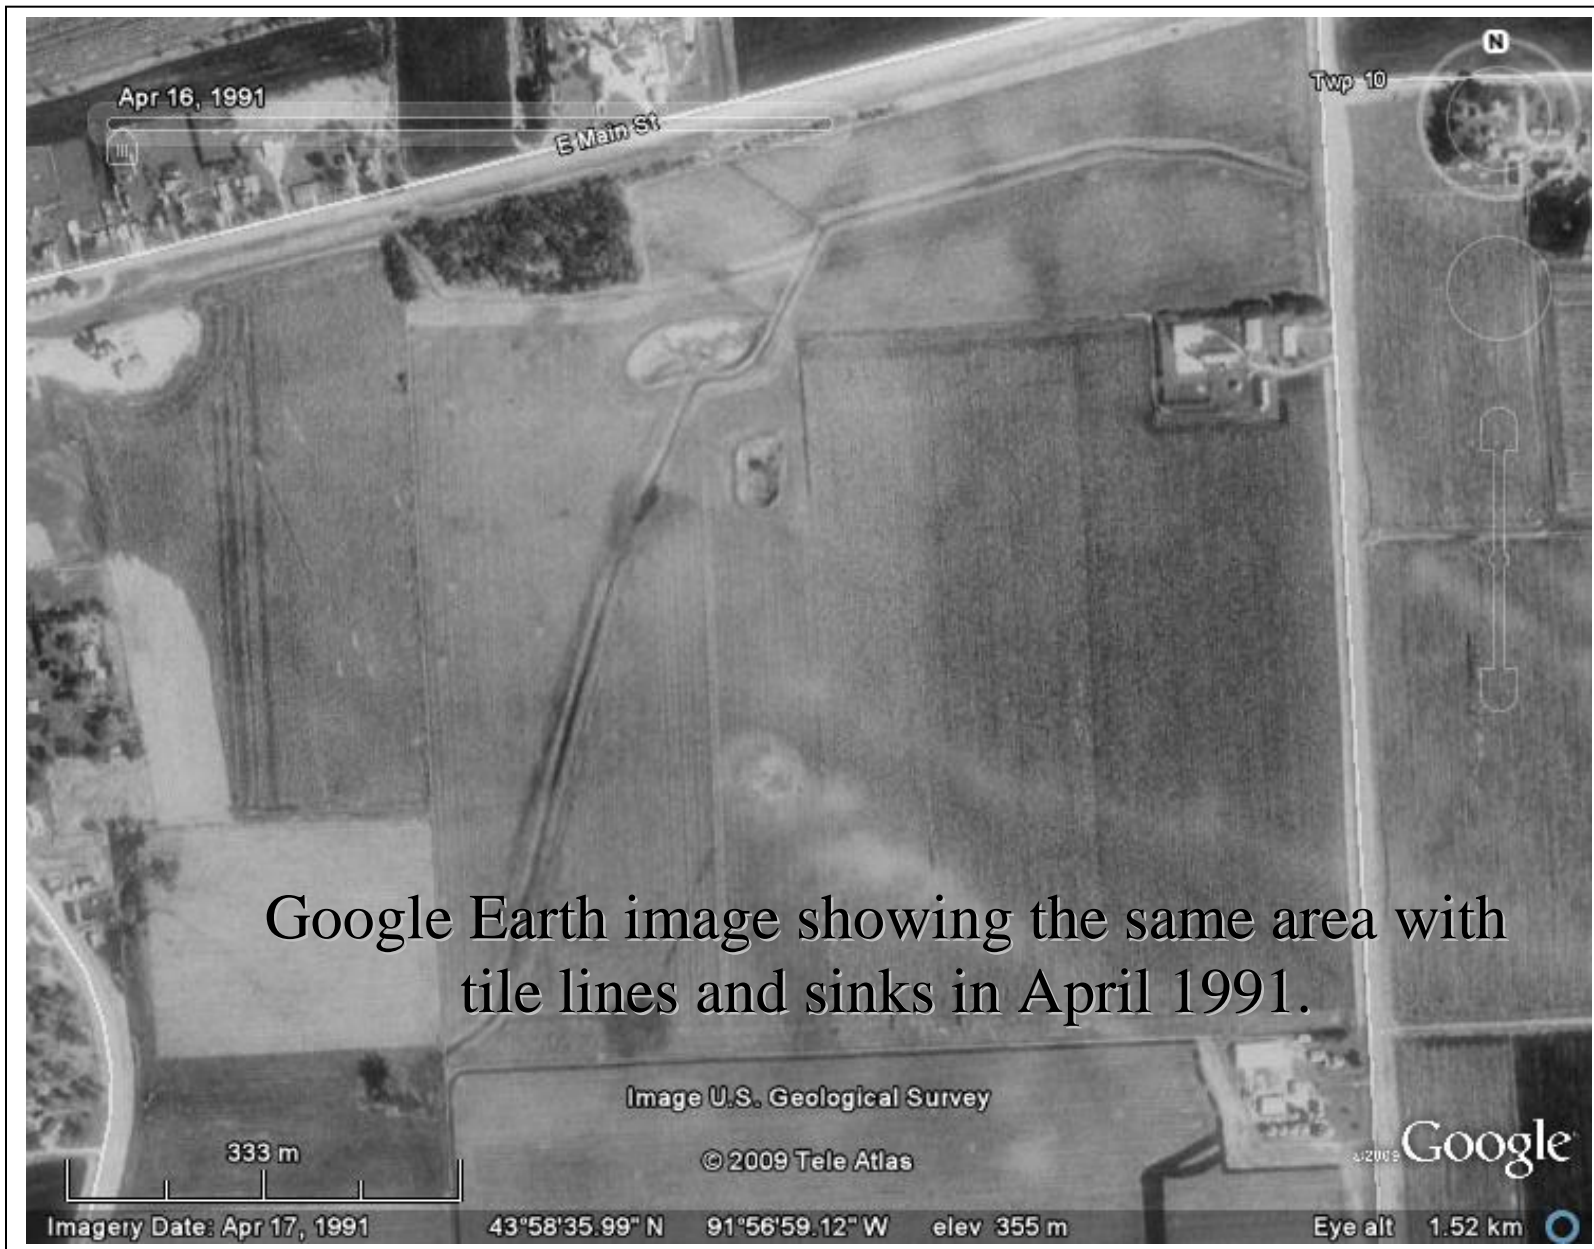
Google Earth image showing the same area with tile lines and sinks in April 1991.

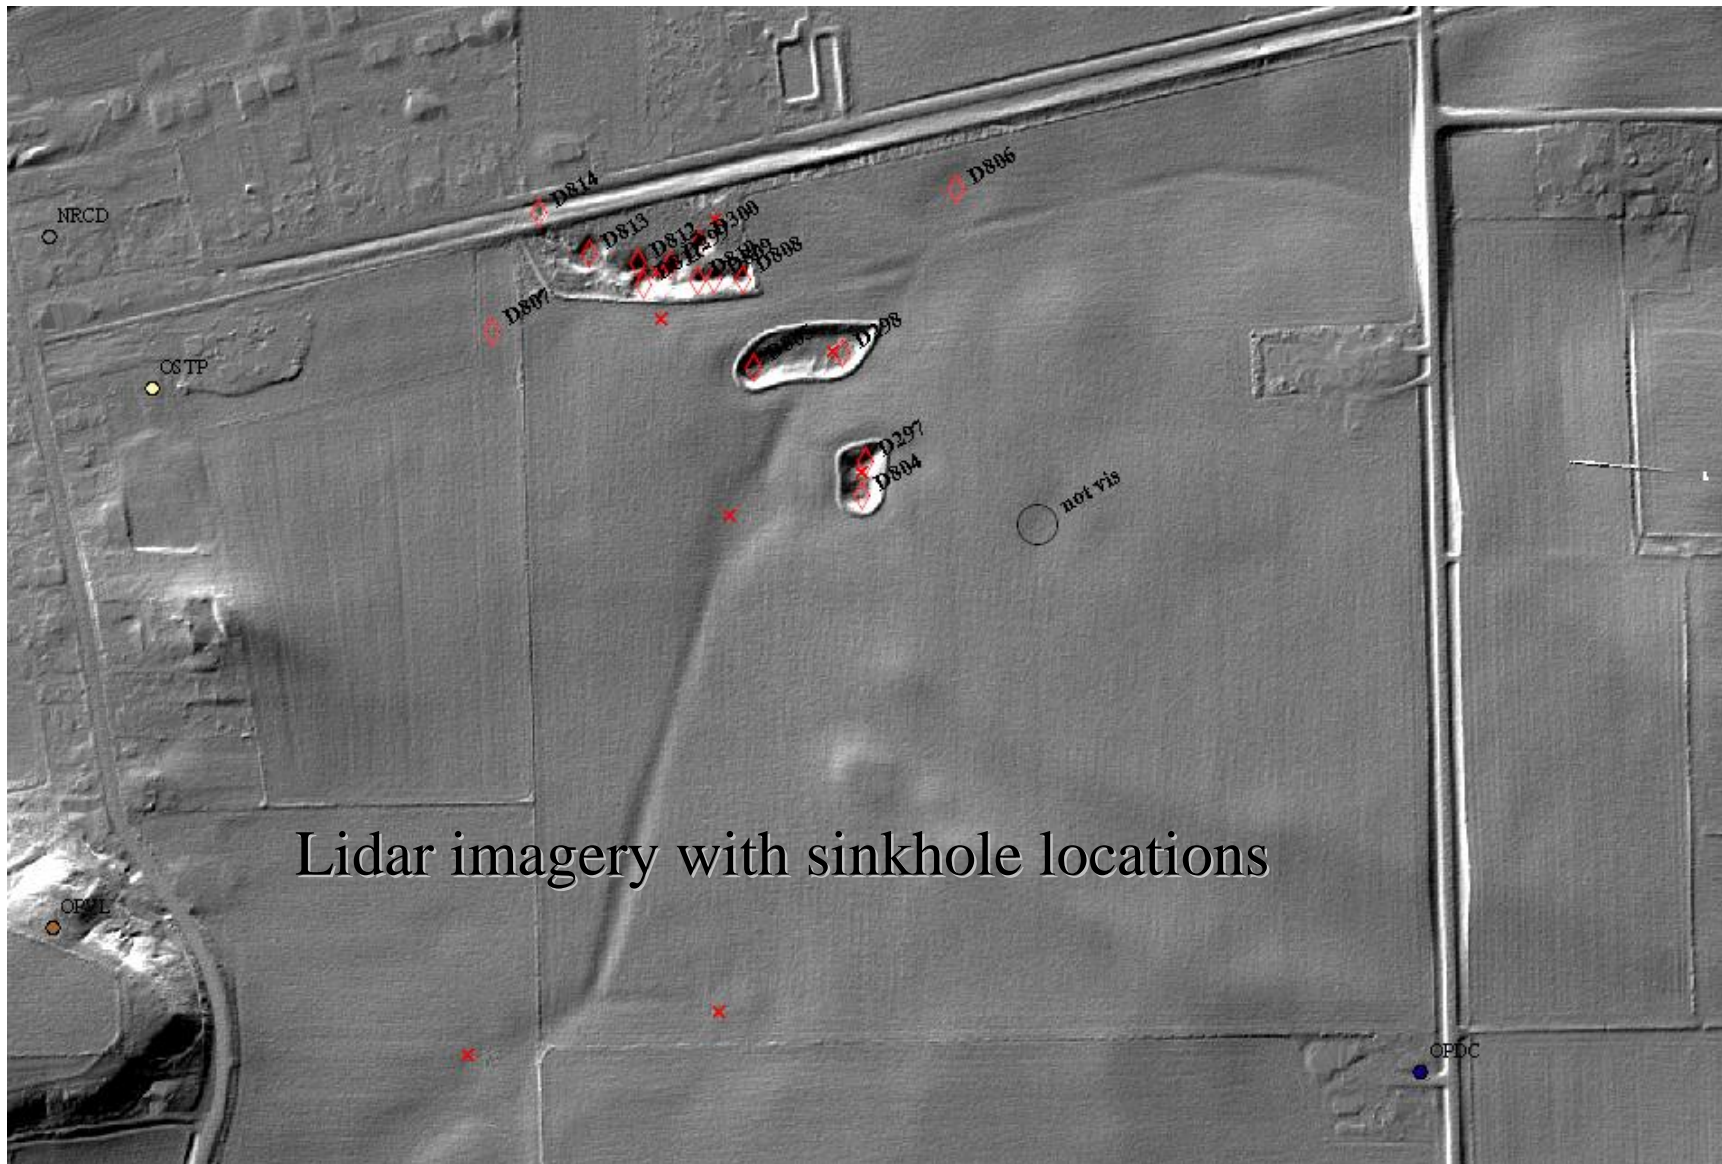
Lidar imagery with sinkhole locations
