Coal Tar Migration in a Multiaquifer Well at the Reilly Site – The Story of Well W23

Introduction and Background

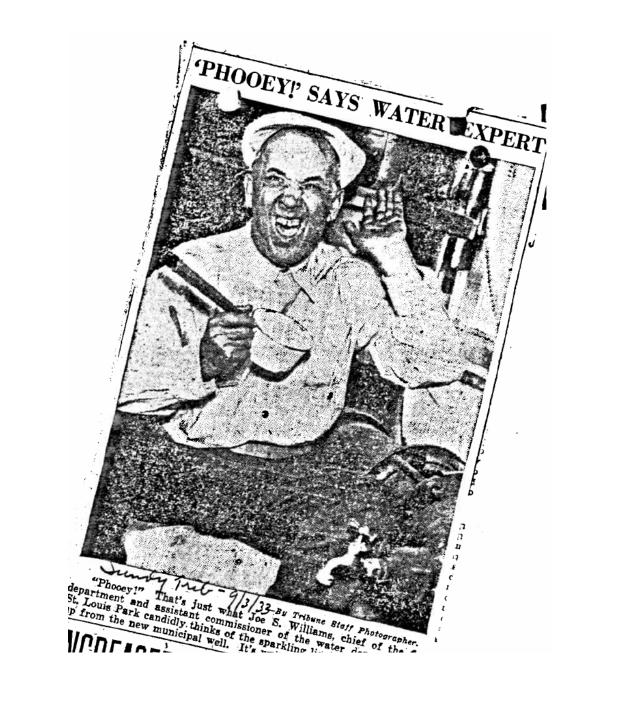
This well always had a crosste taste to the water and we found at the Republic Creosoting Co. plant about one half mile away which were being and it was thought that this creosote was going down in these old wells and passing over thru the crevices in the Shakopee Dolomite and being pumped up into

two old abandoned wells... used to drain creosote down to the ground

The village then kept pumping this well off and on for a period of over a month and they took various tests of the water, but the crocsote did not seem to clear up so ordered us to remove the pump and pipe and packer again, because we agreed to take this material all back again without charge to them. So when we went in to remove the packer we could not get the packer loose, and we had to jack on the pipe to start it loose. It jumped loose and the 8" pipe stripped out of the 8 x 10 cast bushing which was on top of the packer, and all of the pipe was

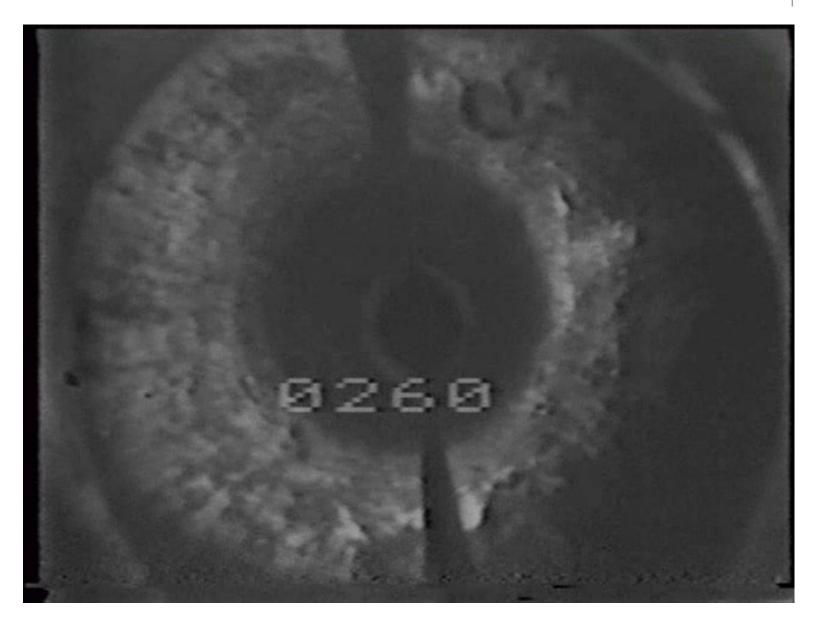
Well W23 Cleanout

- Used cable tool methods to remove the plug of material for W23.
- Found a gravel layer between 653 and 665 feet deep.
- 50+ feet of tarry material had accumulated over the gravel after circa 1956.
- Plug removed but debris & sloughing prevented driller form reaching 909 feet.
- Removed the 10 inch casing that had been installed in 1932.
